PRESSURE CAP ADJUSTMENTS

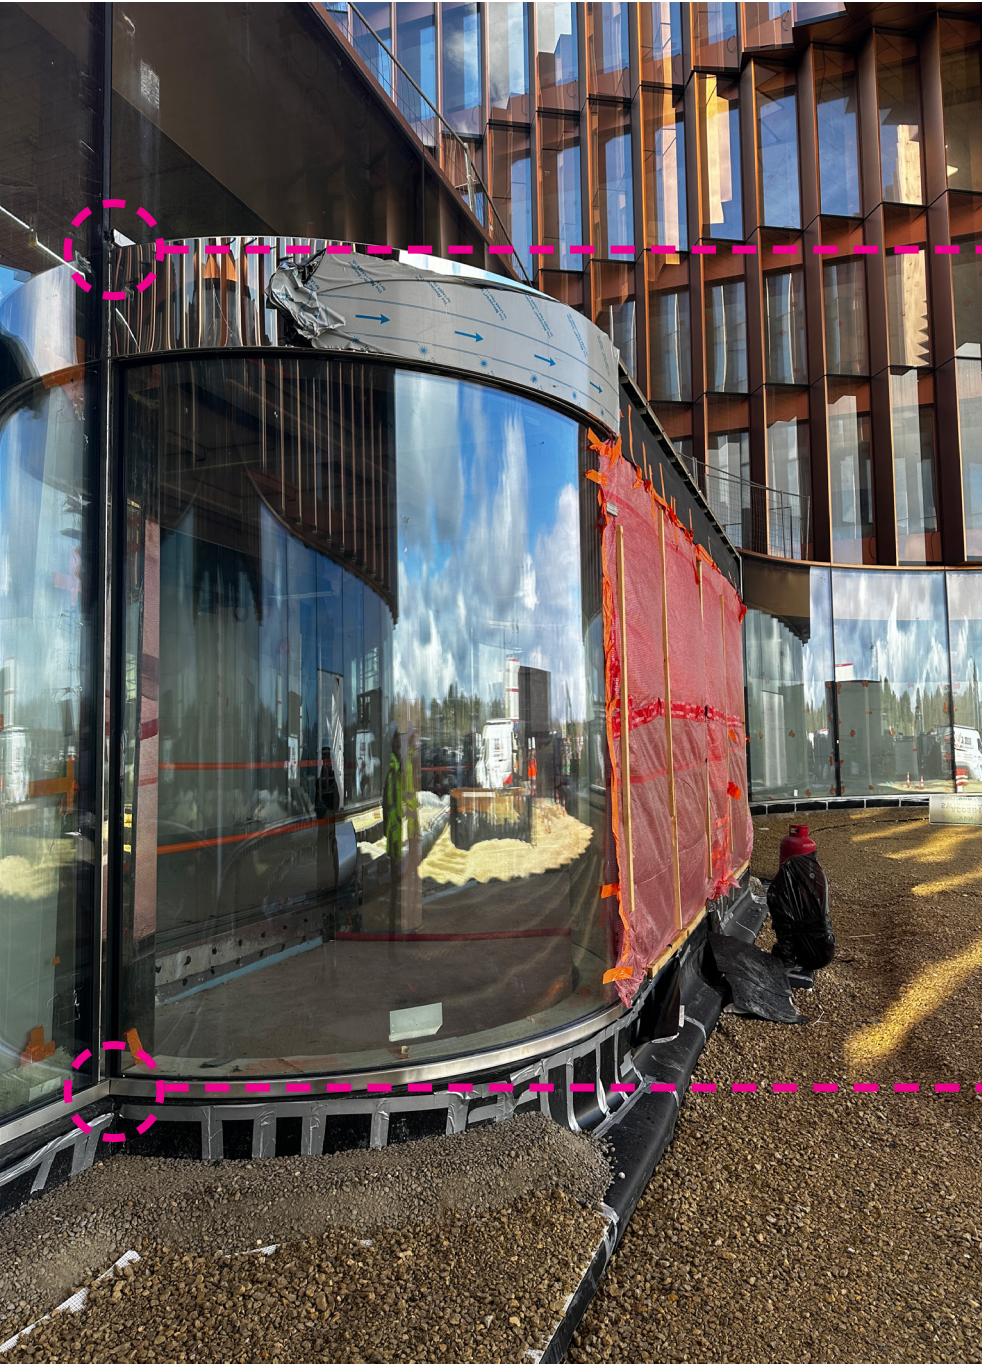
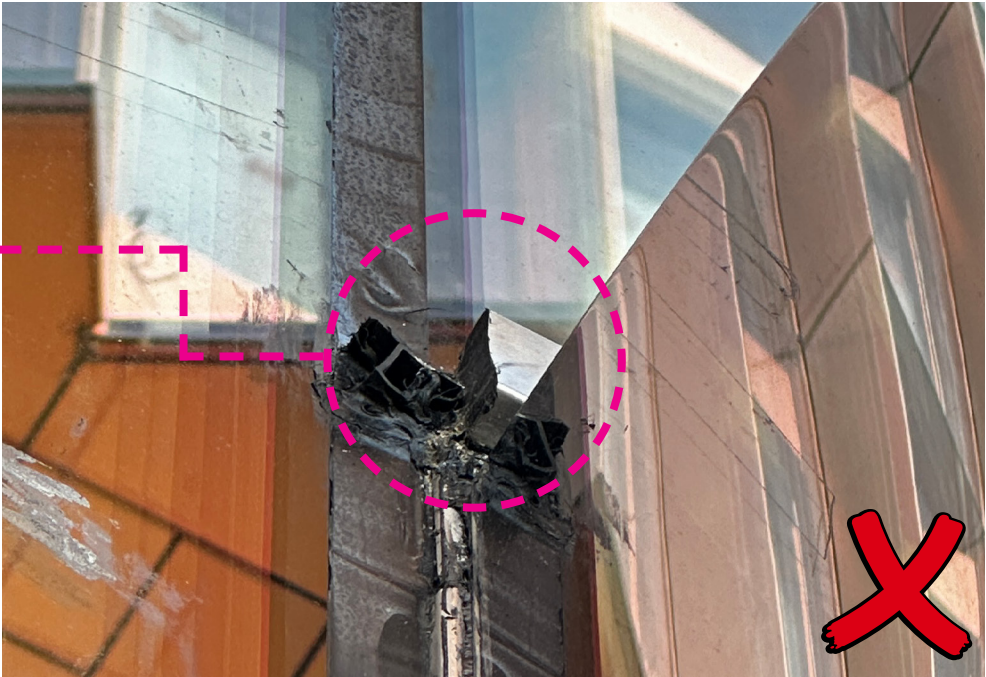
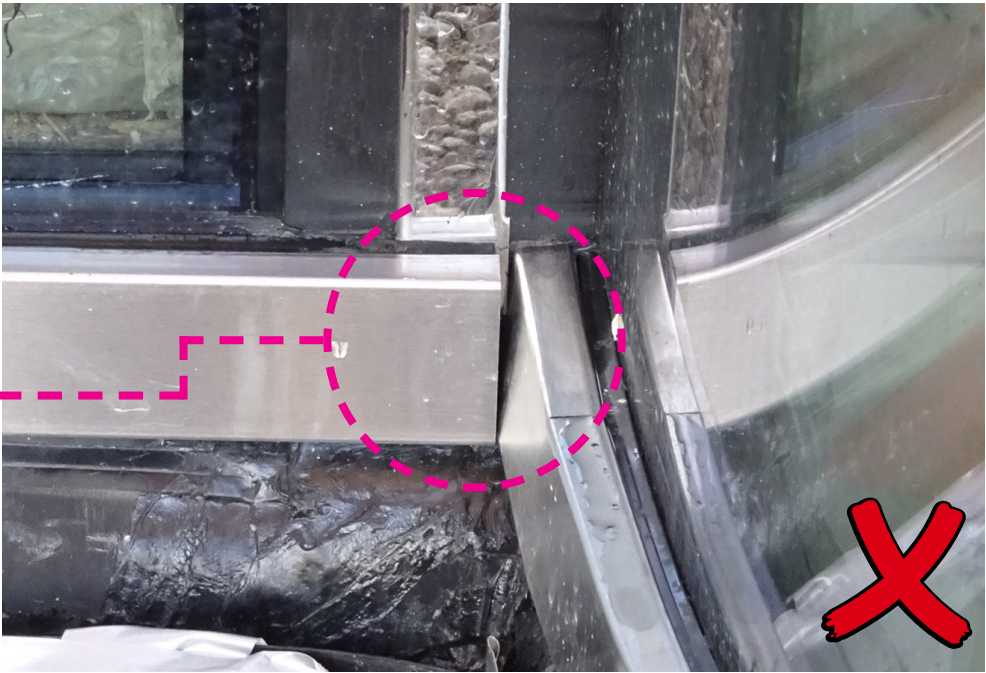
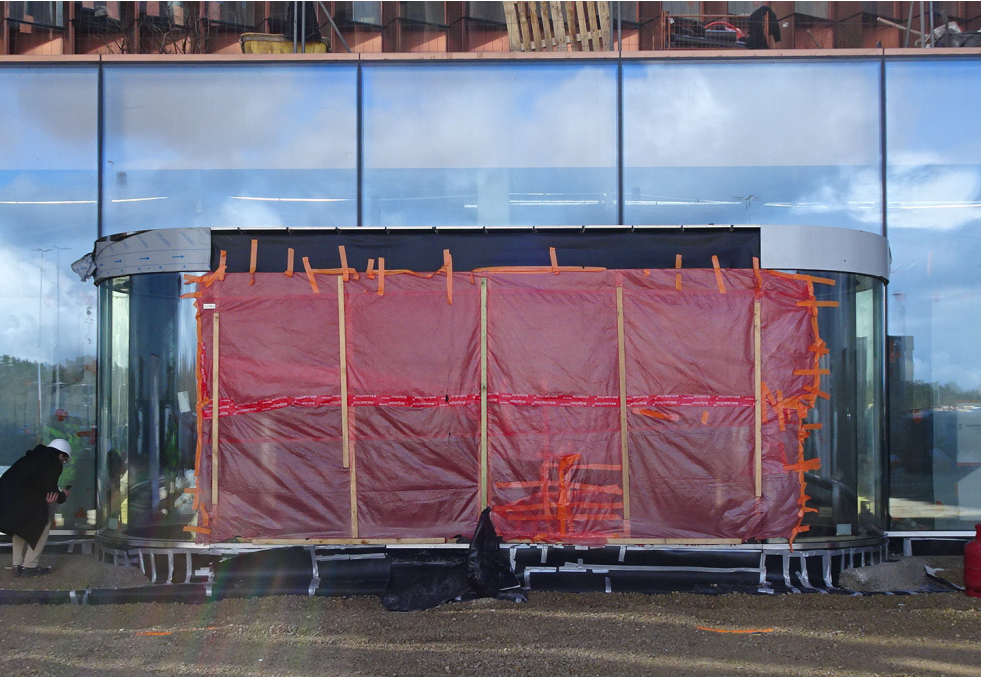
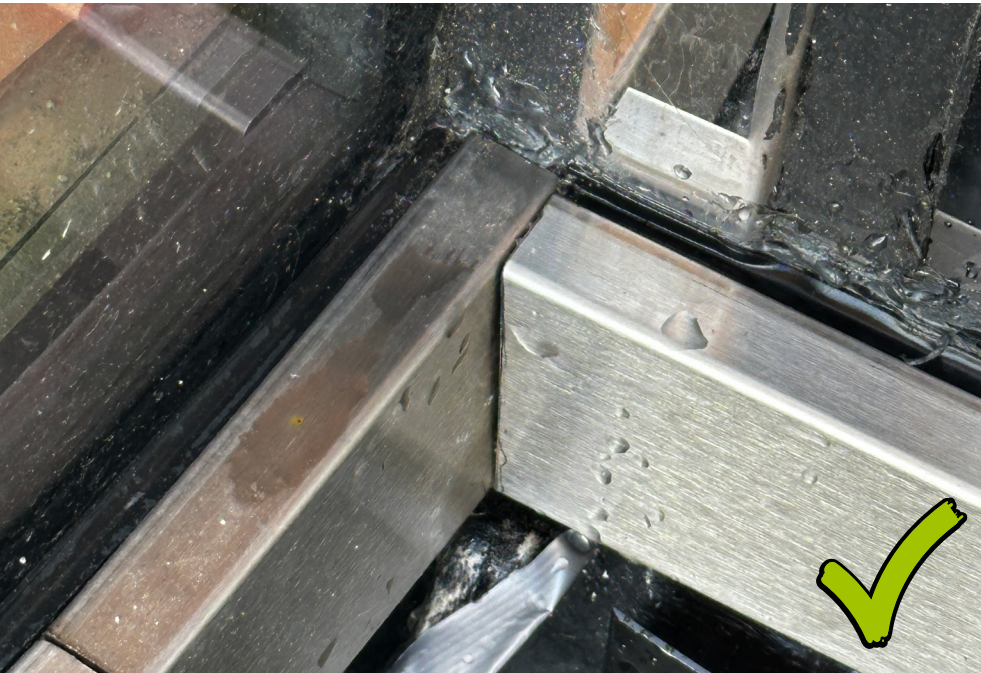
**OBSERVATION:**  
- The pressure caps on the left side of the RDC airlock (top and bottom) are misaligned or broken, however; they are well executed on the right side.

**RECOMMENDATION:**  
- Kyotec to adjust misalignments and replace damaged profiles.

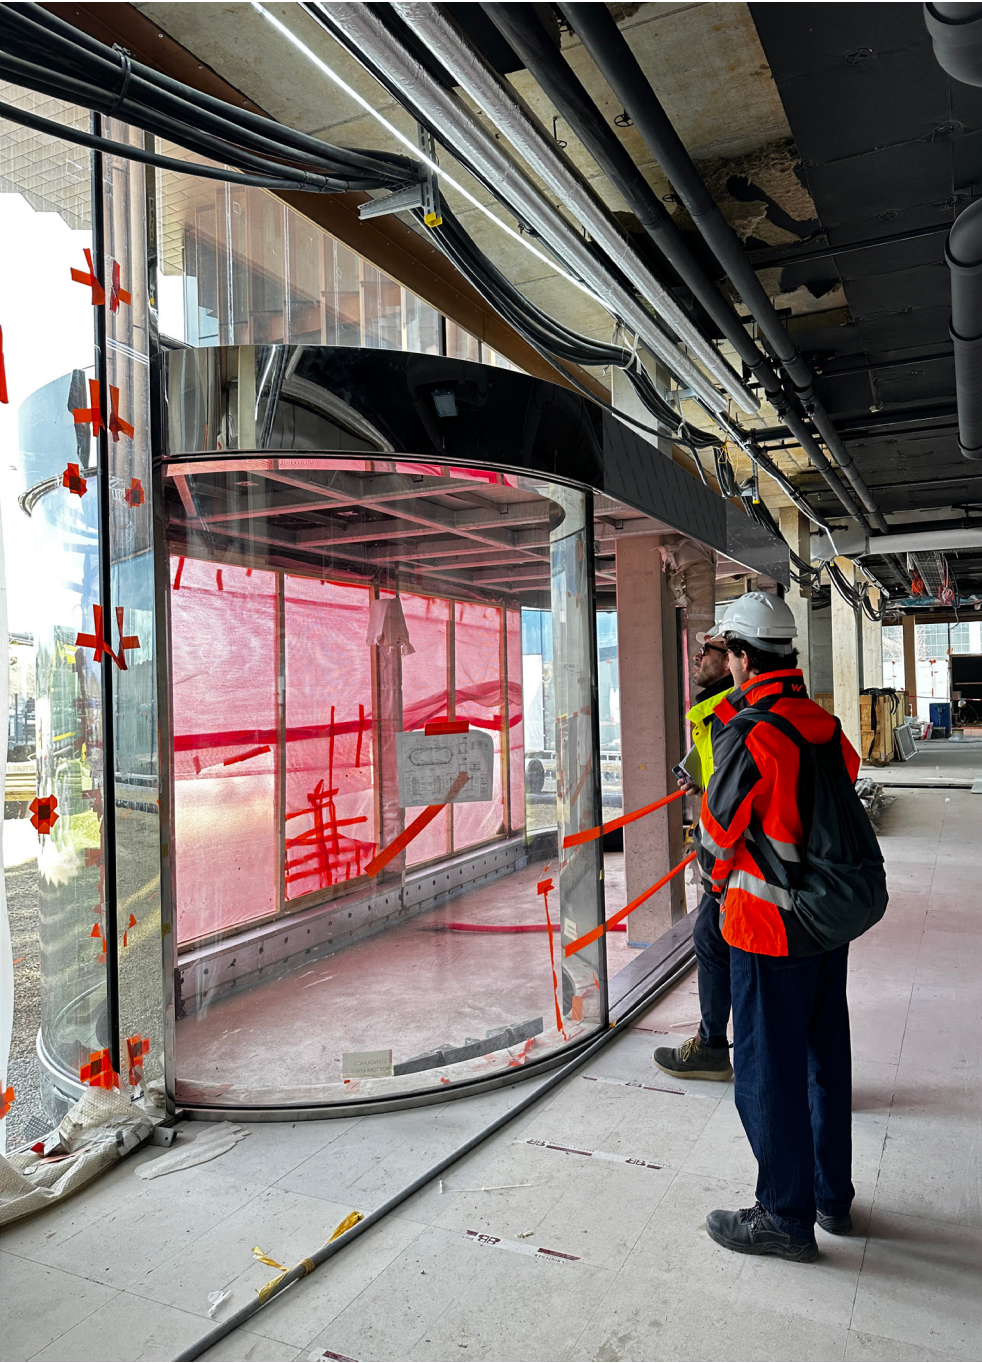
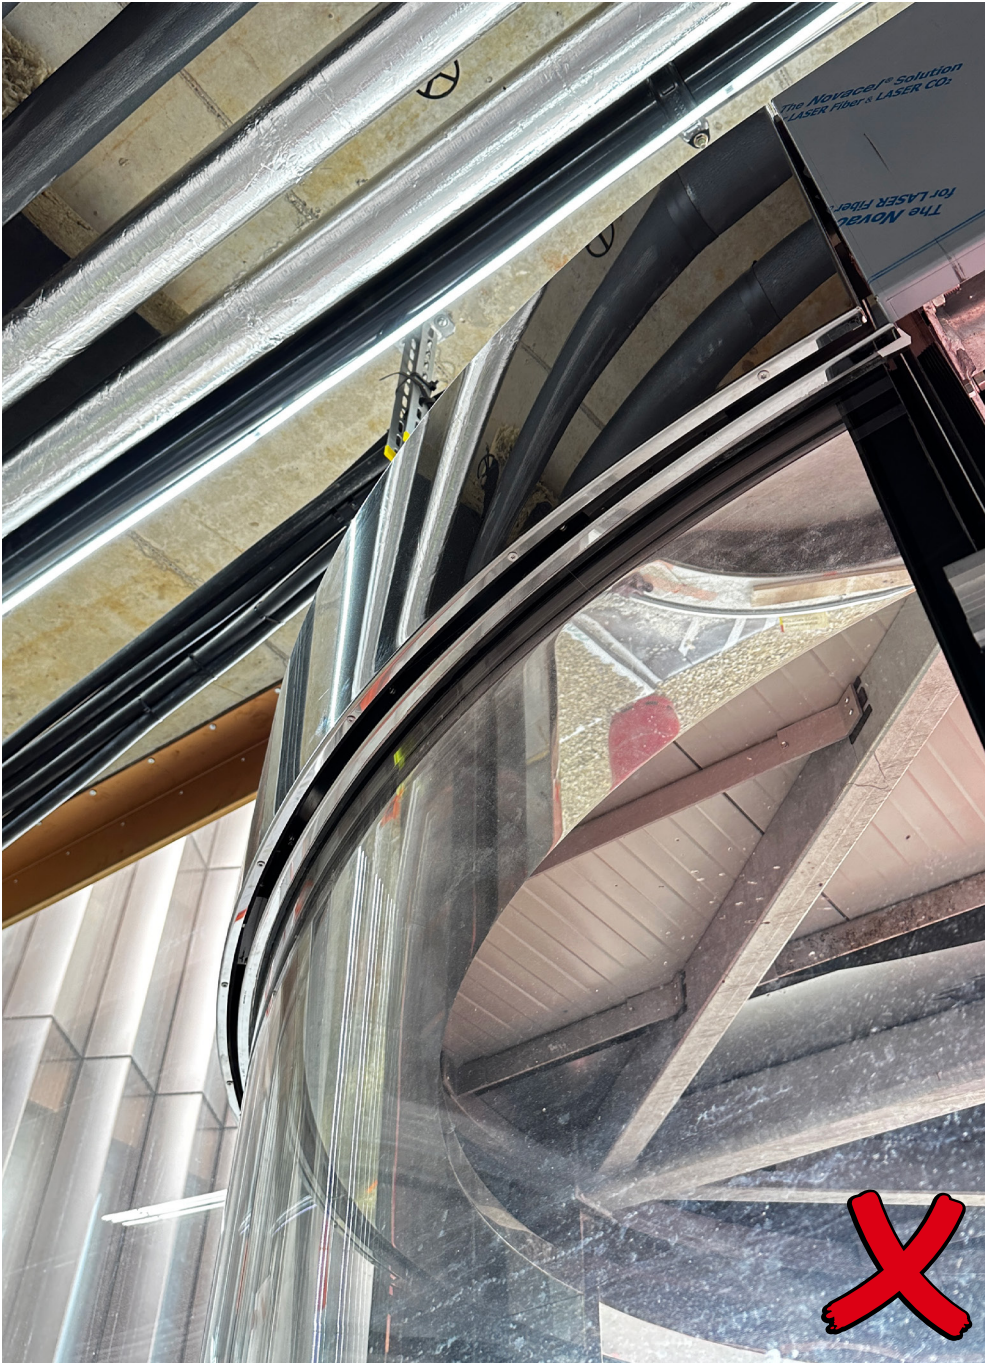
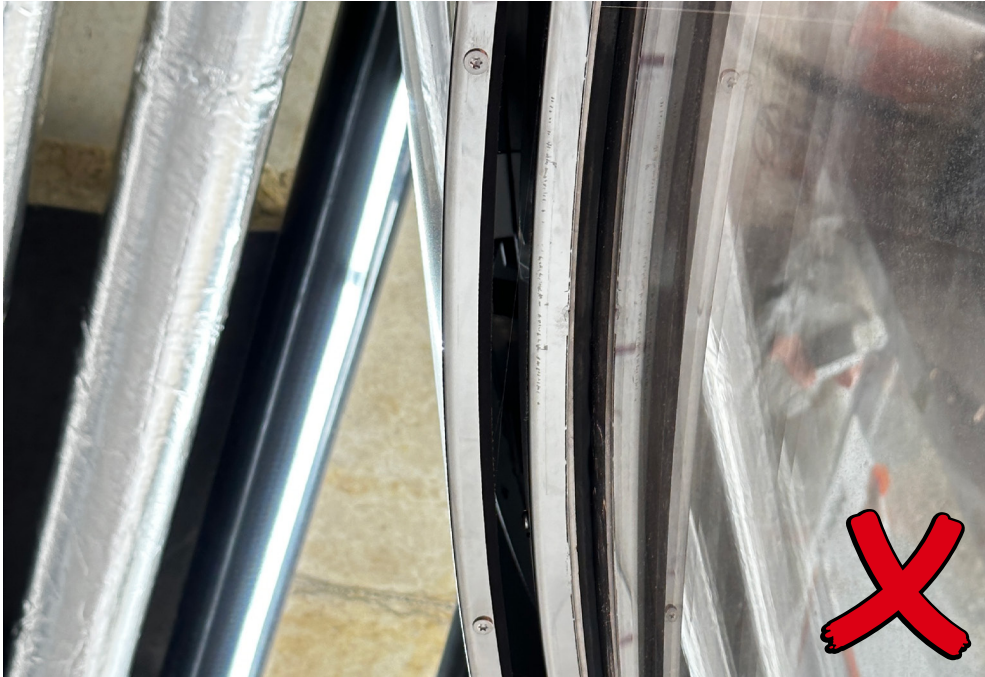
VISIBLE SCREWS ON UNDERSIDE OF TOP PROFILE (INT.)

- The upper panel on the interior side of the RDC airlock has screws visible on the underside. This was not executed as per the last approved detail by BIG, which has all fasteners concealed internally.

- Kyotec to replace panels and execute the installation as per the last approved detail.

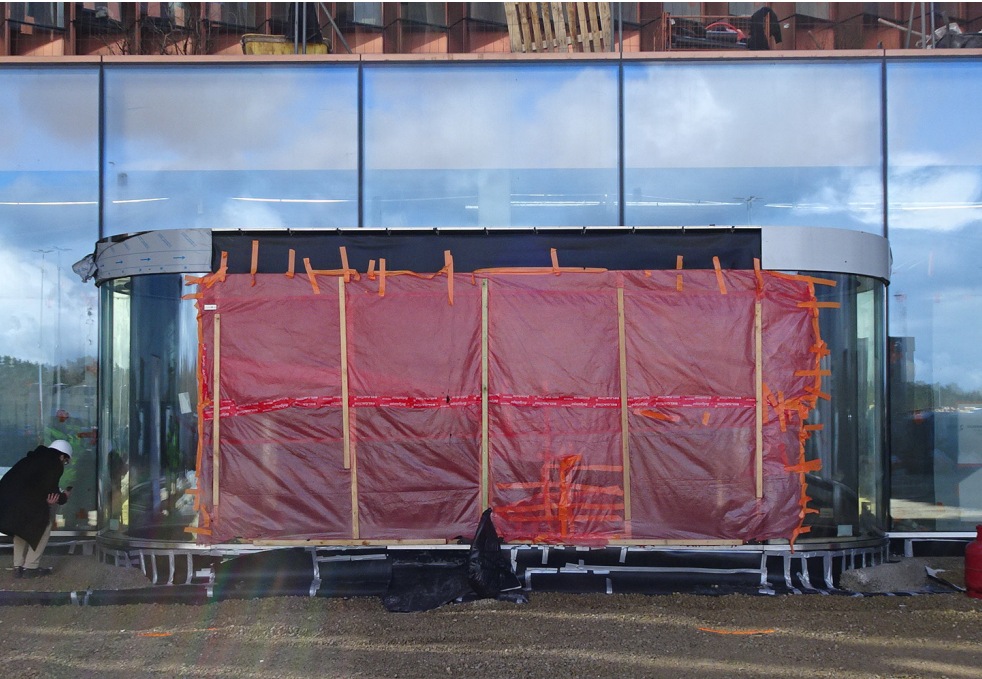
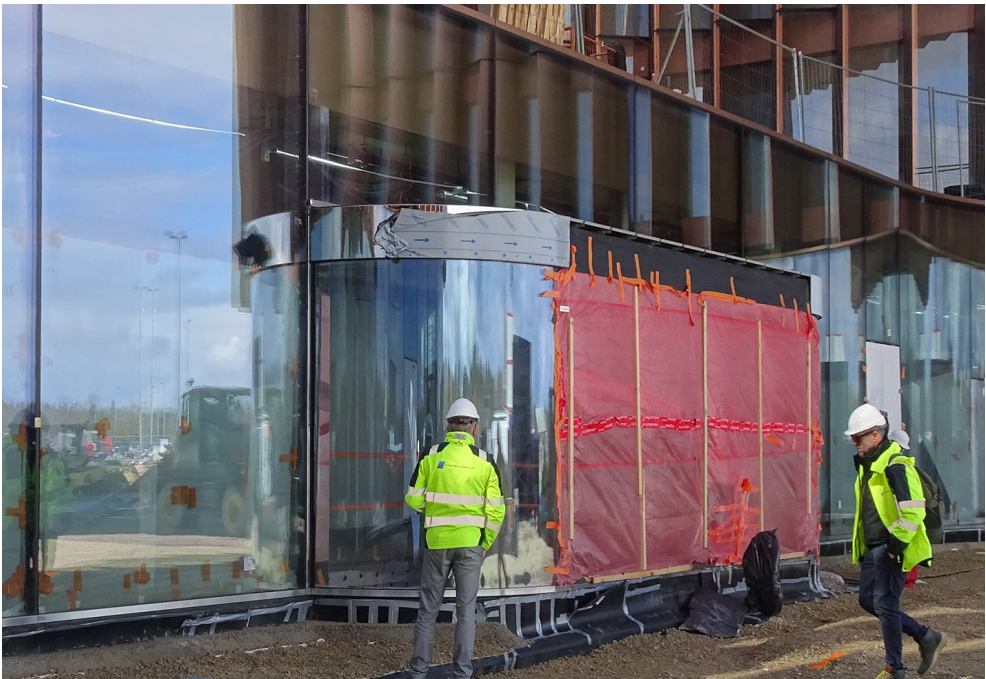
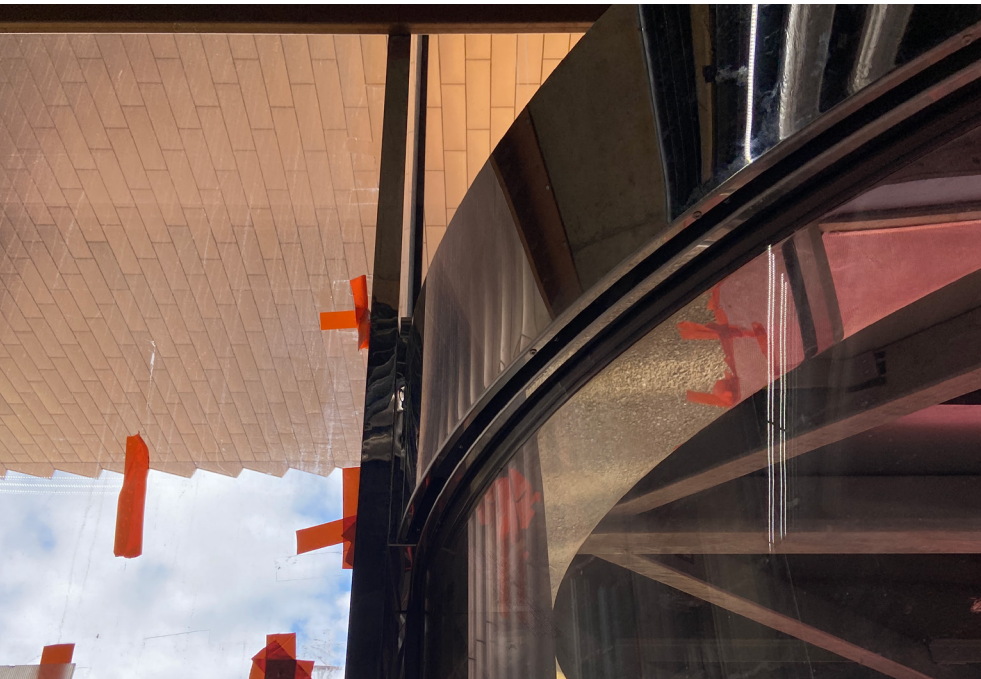
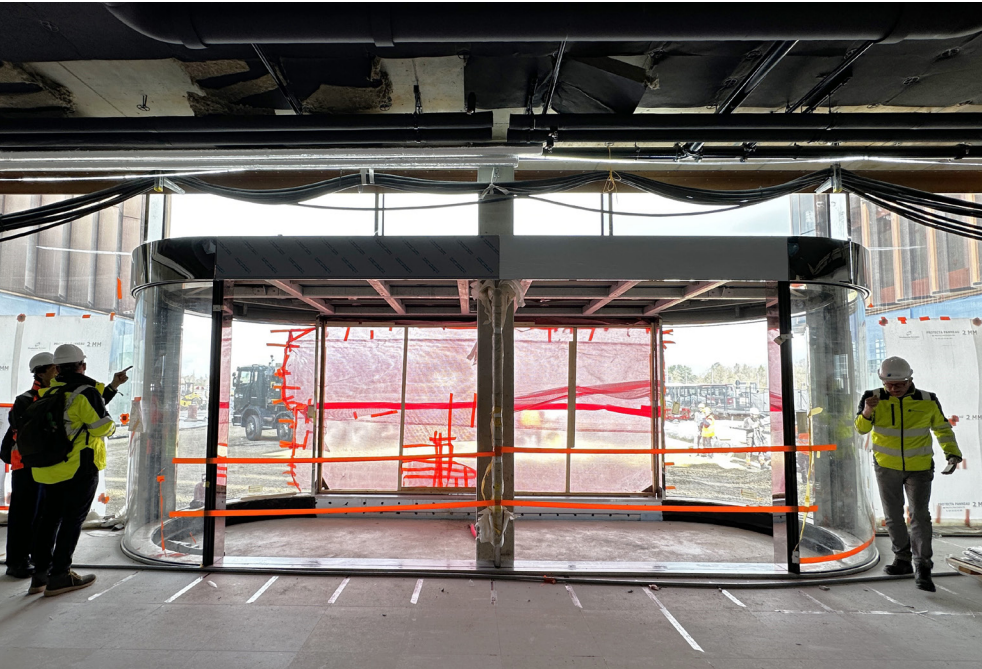
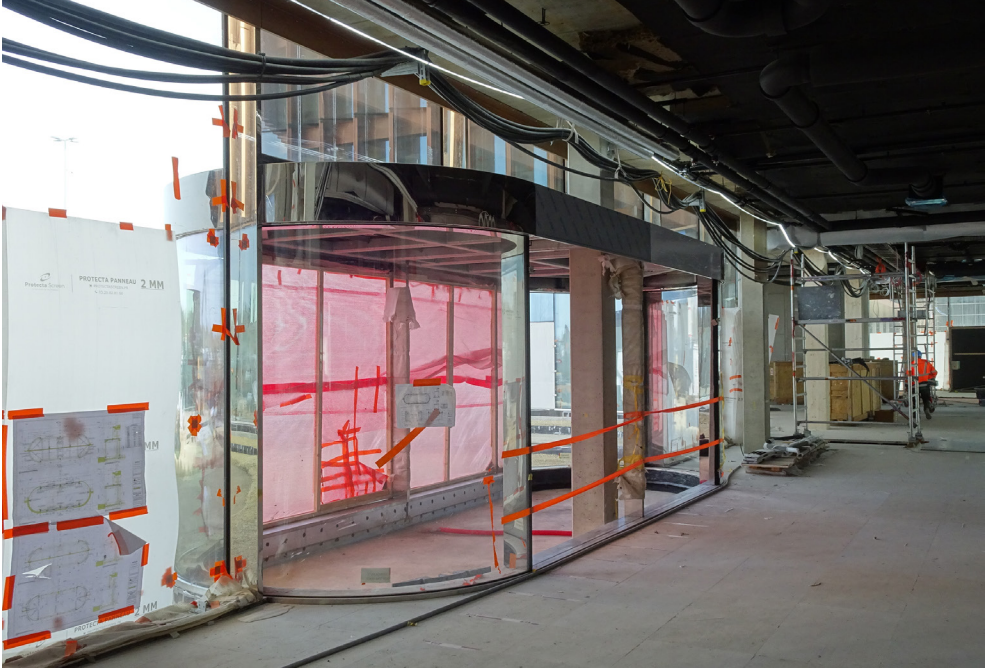
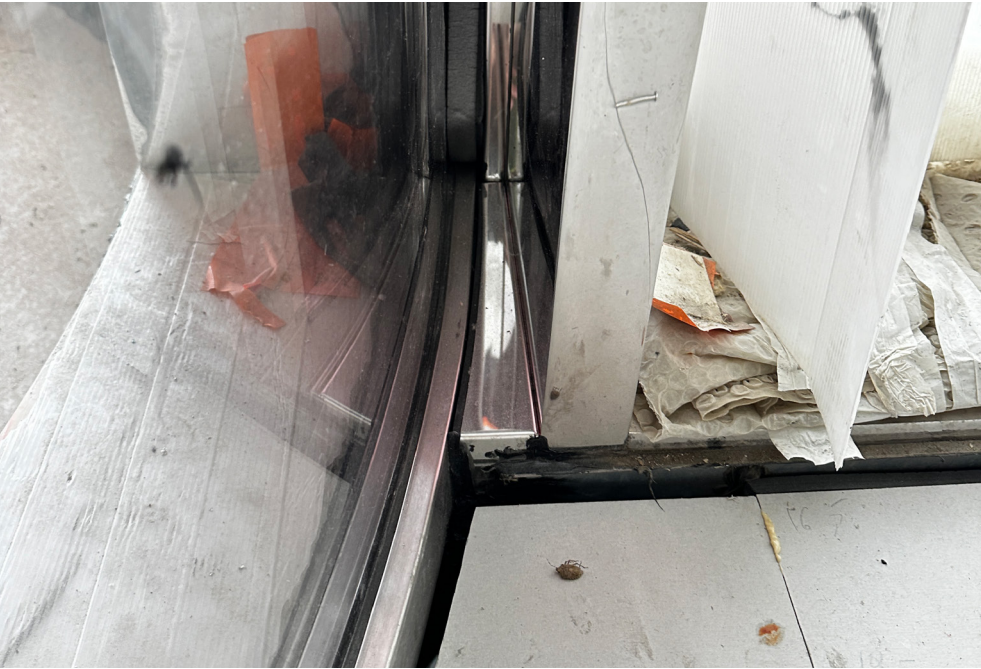
OVERALL EXECUTION

**OBSERVATION:**  
- The overall appearance and details of the RDC airlock are well executed and the insertion and interface with the stick facade looks nice. Additionally, the appearance of the mirror finish is nice both internally and externally.

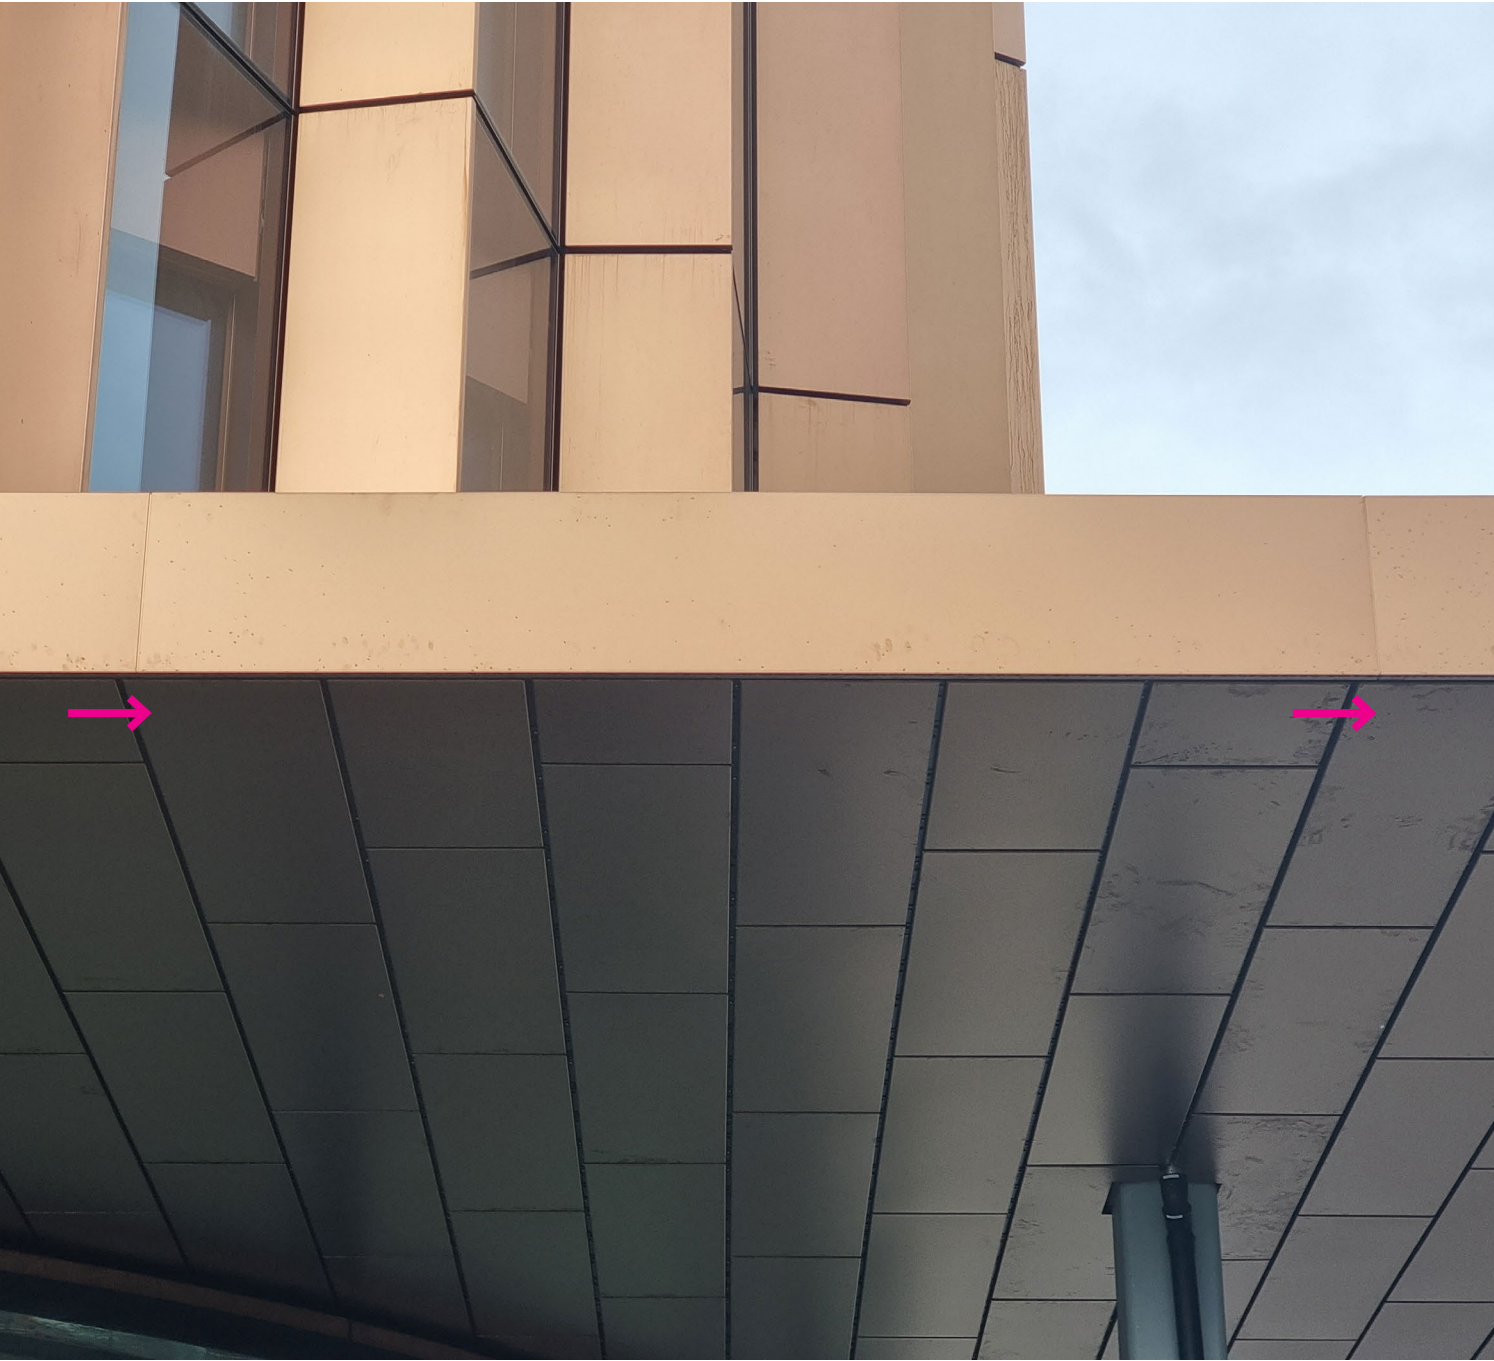
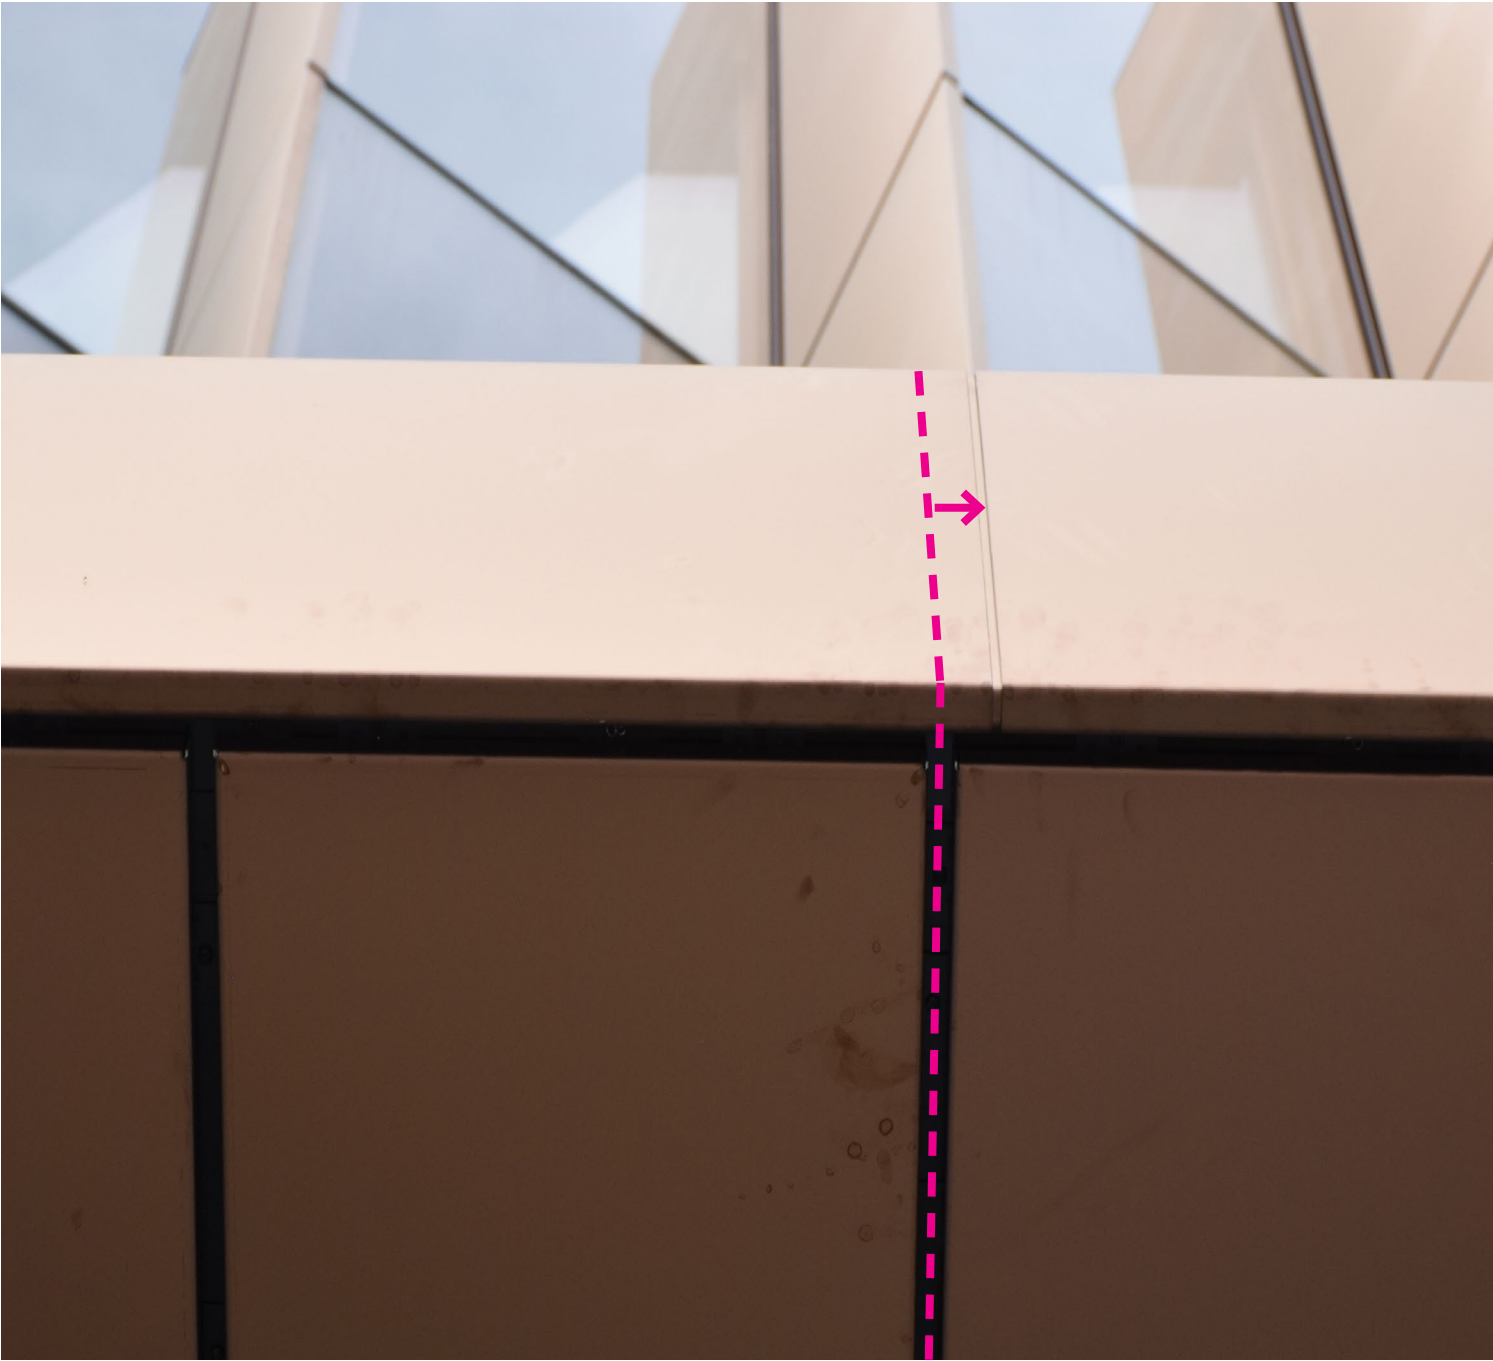
PANEL EXECUTION: JOINTS OF EDGE PANEL / SOFFIT

**OBSERVATION:**  
- THE JOINTS BETWEEN THE EDGE PANELS AND THE SOFFIT ARE SLIGHTLY OFFSET AND MISALIGNED. THIS AGAIN SUPPORTS THE OBSERVATION THAT THE SOFFIT PANELS SHOULD BE SHIFTED TOWARD THE TERMINAL.

**RECOMMENDATION:**  
- IF POSSIBLE, SHIFT THE SOFFIT PANELS TOWARDS THE TERMINAL. IF THE SHIFT IS NOT POSSIBLE, RE-CUT THE FRONT PANELS SO THAT THE JOINTS ARE ALIGNED WITH THOSE OF THE SOFFIT PANELS BELOW.

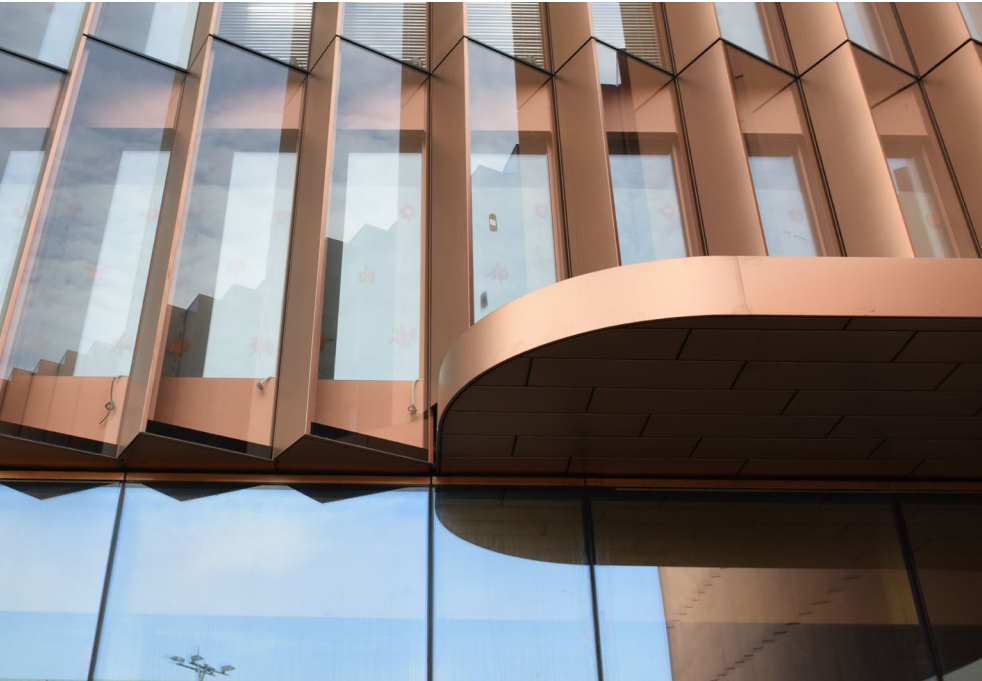
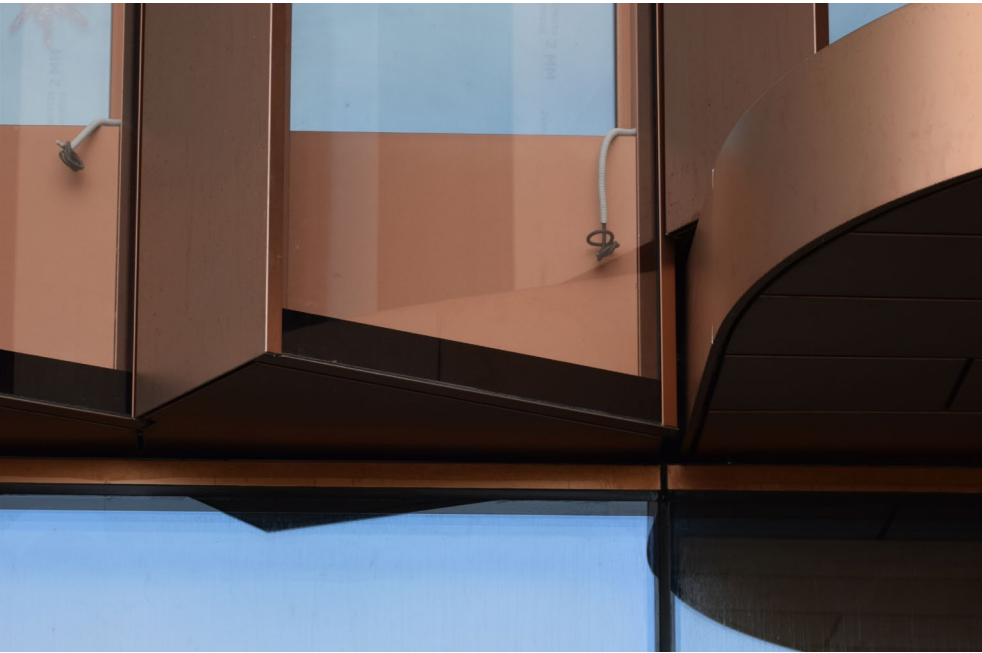
PANEL EXECUTION: GAP AT HOTEL SIDE

**OBSERVATION:**  
- OVERALL EXECUTION HERE IS GREAT, HOWEVER; THE GAP ON THE BOTTOM SIDE LEAVES SOME OF THE SUBSTRUCTURE VISIBLE FROM BELOW.

**RECOMMENDATION:**  
- INSTALL A SMALL FLASHING OR SOMETHING BLACK (VERTICALLY ON TO THE STRUCTURE) TO MINIMIZE THE VISIBILITY OF THE GALVANIZED STRUCTURE.

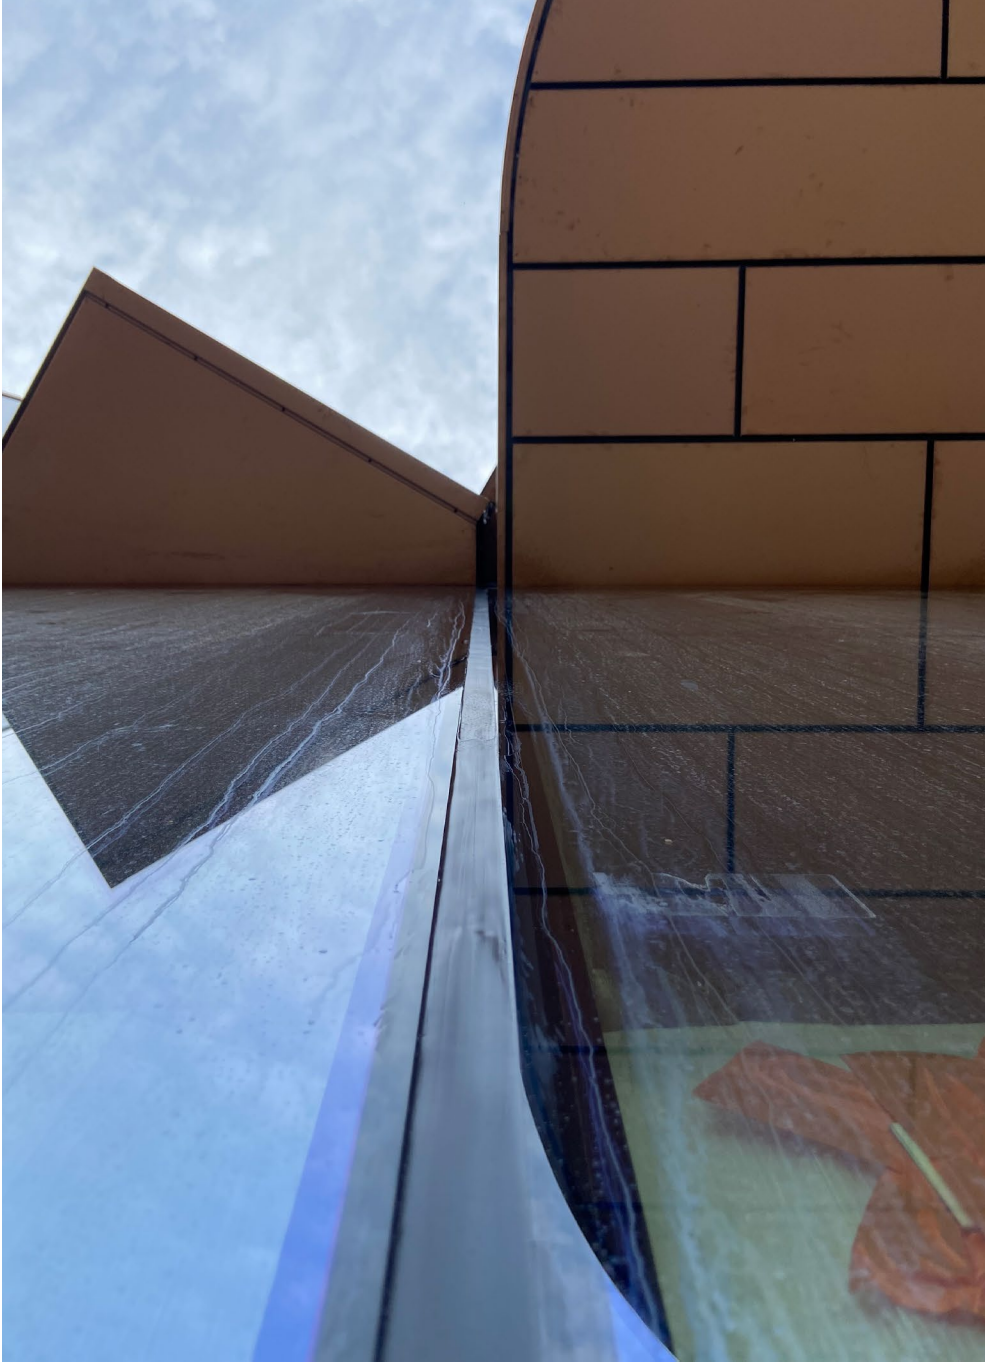
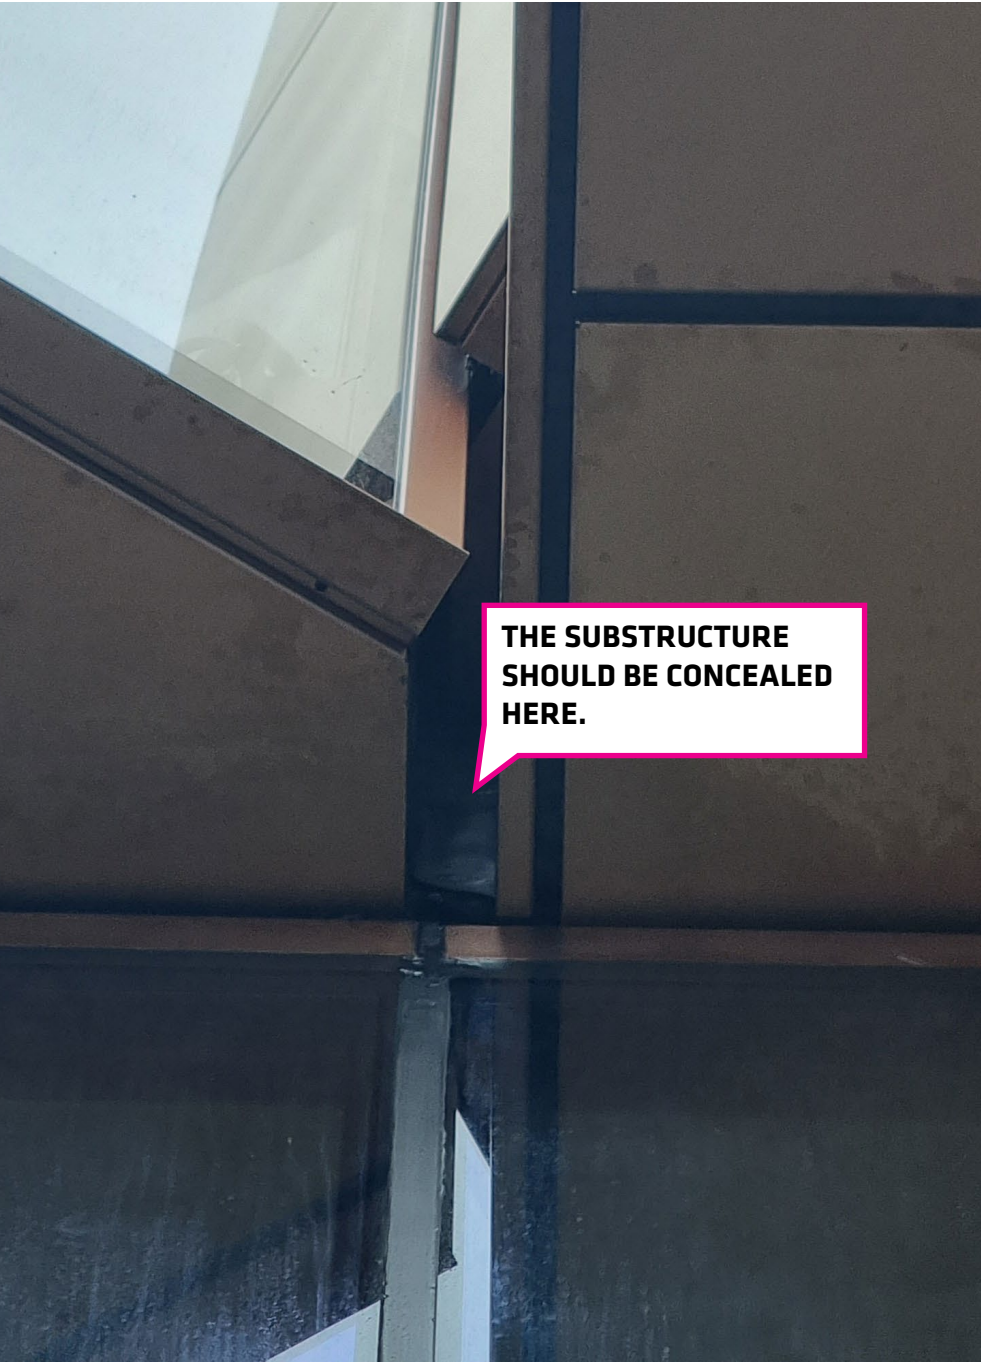
THE SUBSTRUCTURE SHOULD BE CONCEALED HERE.
