PRESSURE CAP ADJUSTMENTS

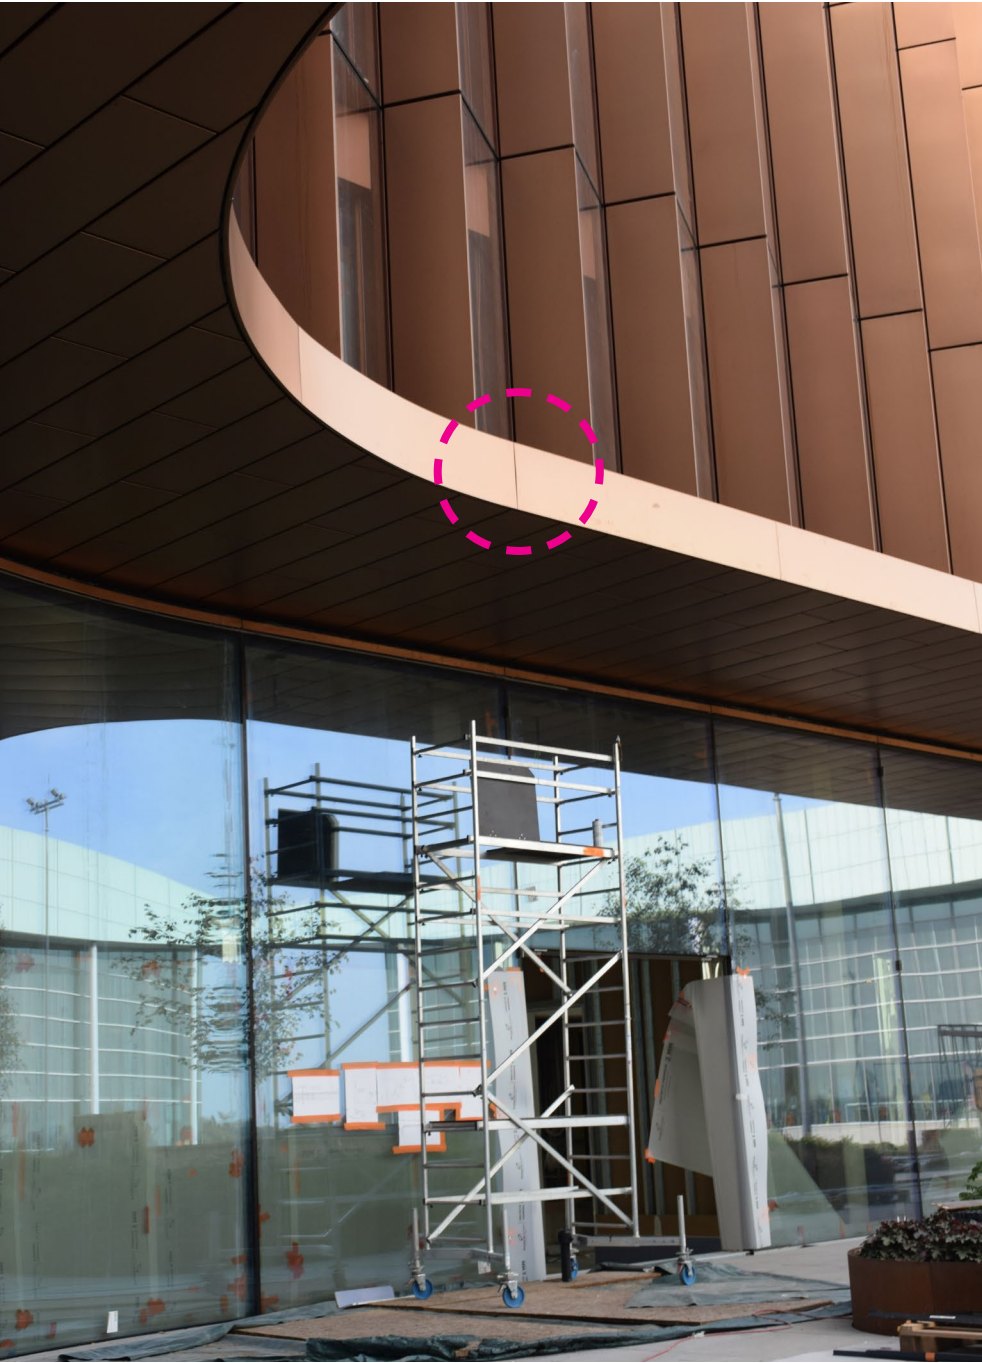
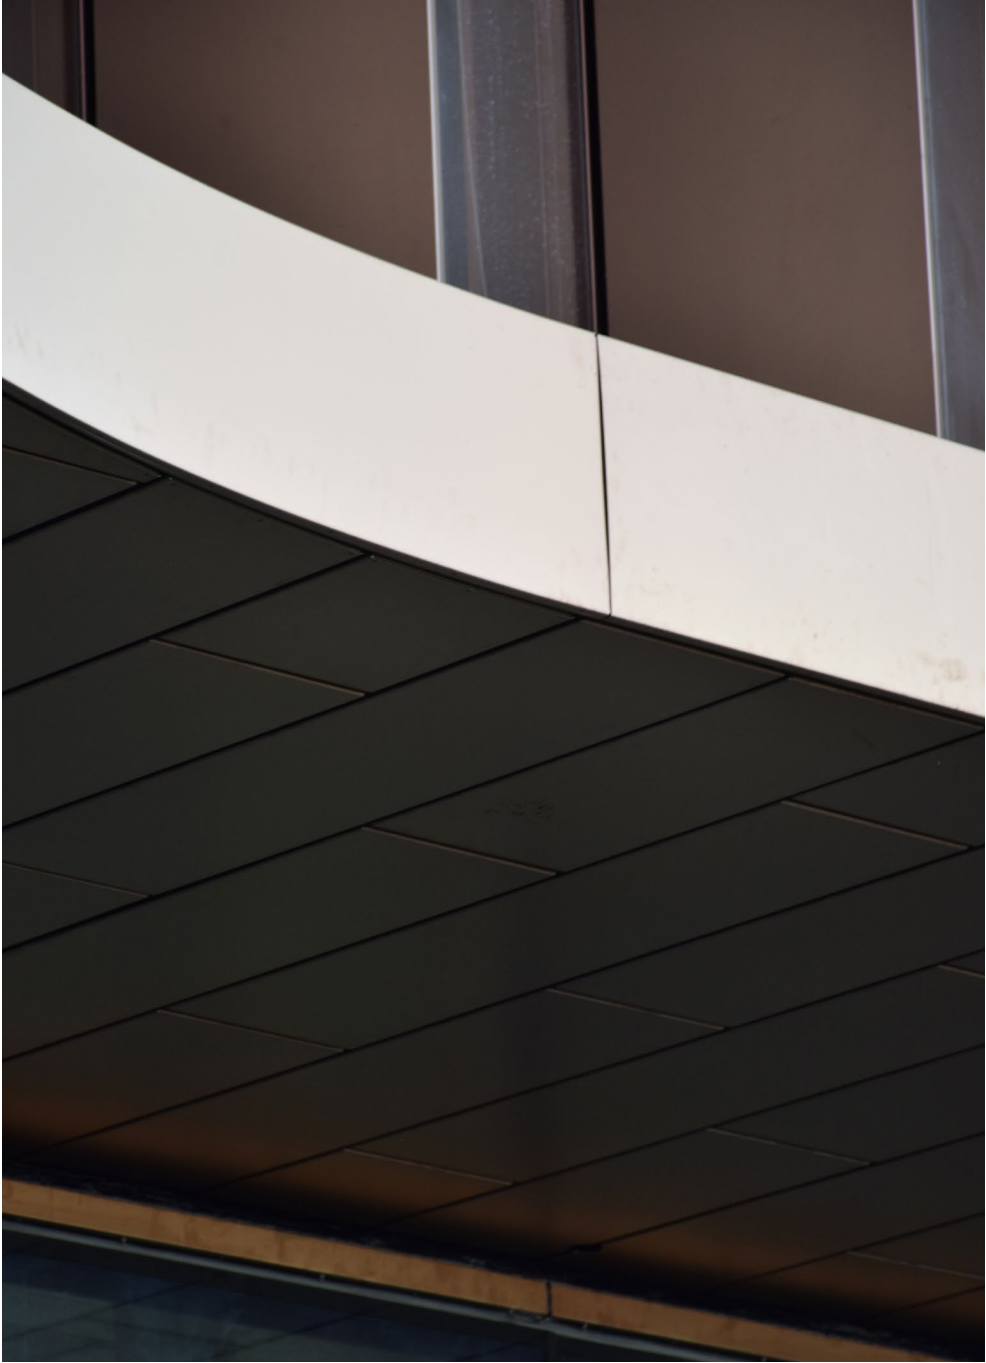
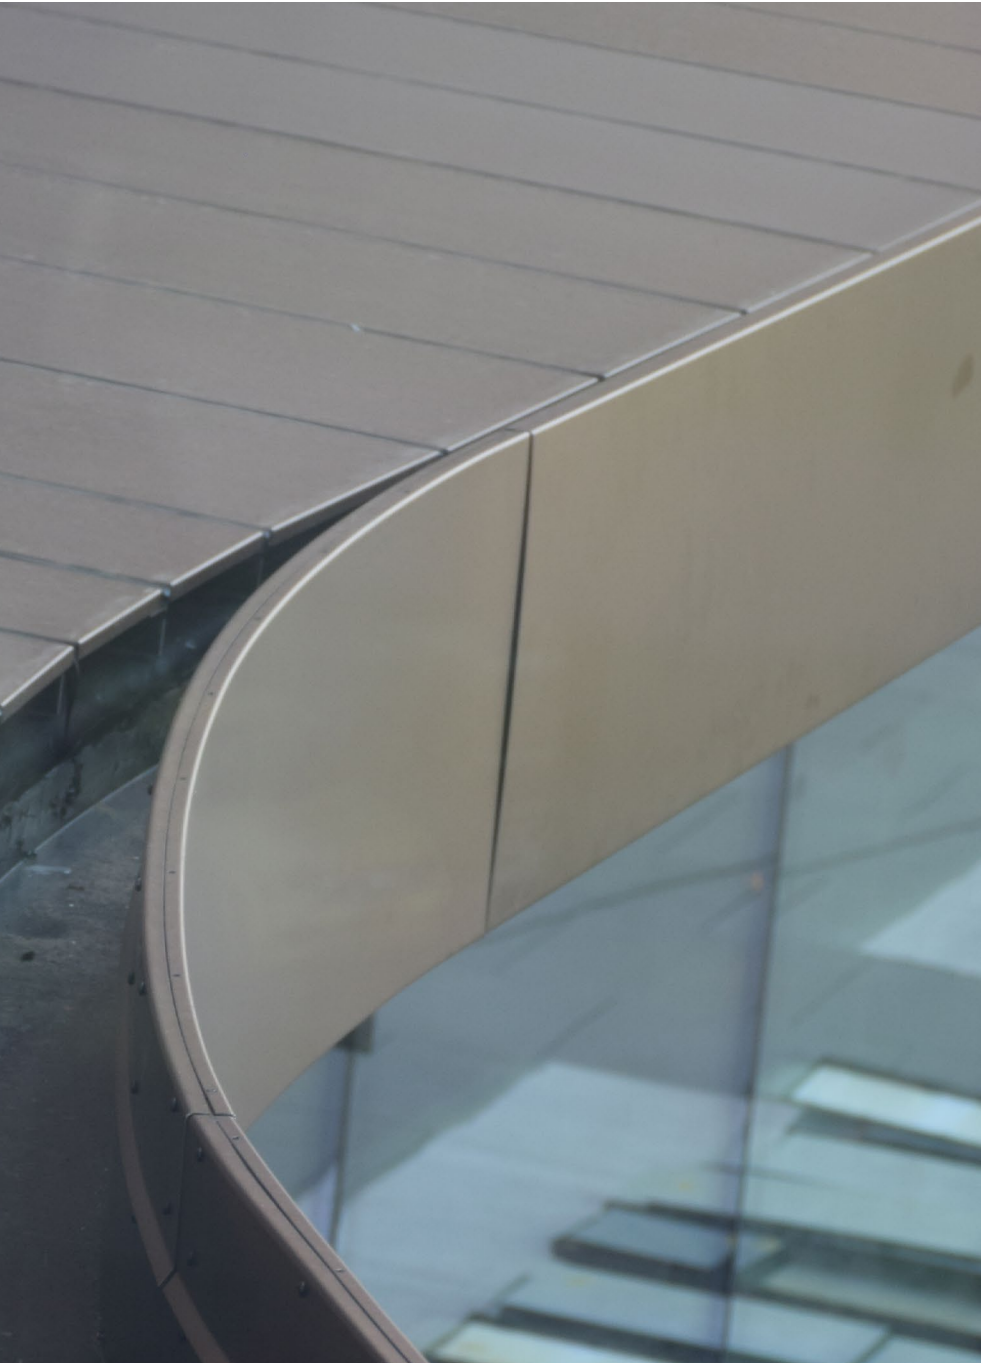
PANEL EXECUTION: SECOND JOINT AT CURVE

**OBSERVATION:**  
- THE APPEARANCE OF THIS JOINT IS UNSATISFACTORY AND THE PANEL SEEMS TO BE DENTED OR WARPED, CREATING A GAP.

**RECOMMENDATION:**  
- REPLACE OR ADJUST PANELS.
